Demonstration and Validation of Stainless Steel Materials for Critical Above-Grade Piping in Highly Corrosive Locations

Final Report on Project F07-AR15

Under Project F07-AR15, "Advanced Corrosion-Resistant Steel for Rehabilitation of
Fire-Suppression System Pipelines for Okinawa Fuel Tanks"

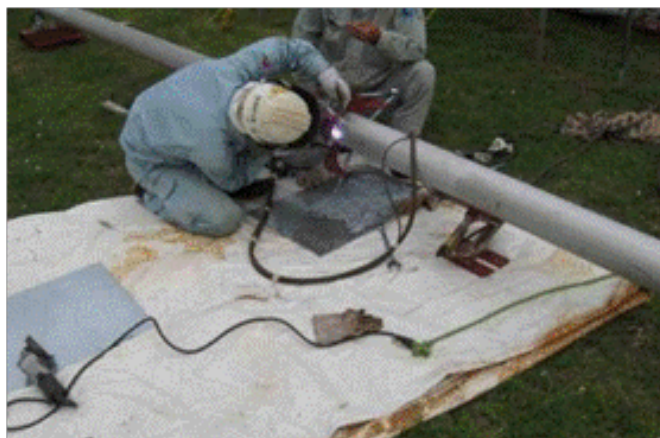
Figure 4. Arc welding replacement pipes.

The pipeline was assembled using tungsten inert gas (TIG) arc welding. Pipe segments were joined at a stationary location to form longer segments, which were then transported to the appointed final assembly location. Figure 4 shows workers welding the new pipe together.

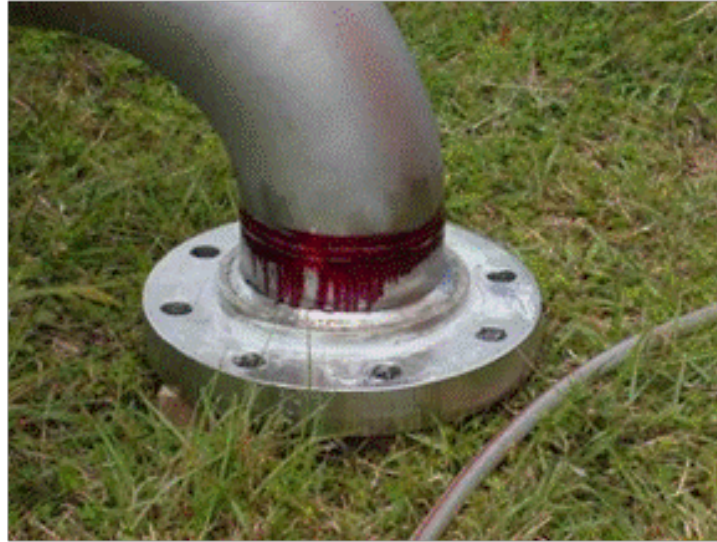
Figure 5. DPT application for nondestructive testing of welds.

The quality of the welds joining the new pipe sections was tested several times. First, an independent testing firm was retained to inspect each weld using nondestructive procedures. A liquid dye penetrant test (DPT) was applied after the weld was completed (Figure 5). The results of that testing

are provided in Appendix I. No defective welds were discovered. The results of the DPT were logged with identification of each joint.

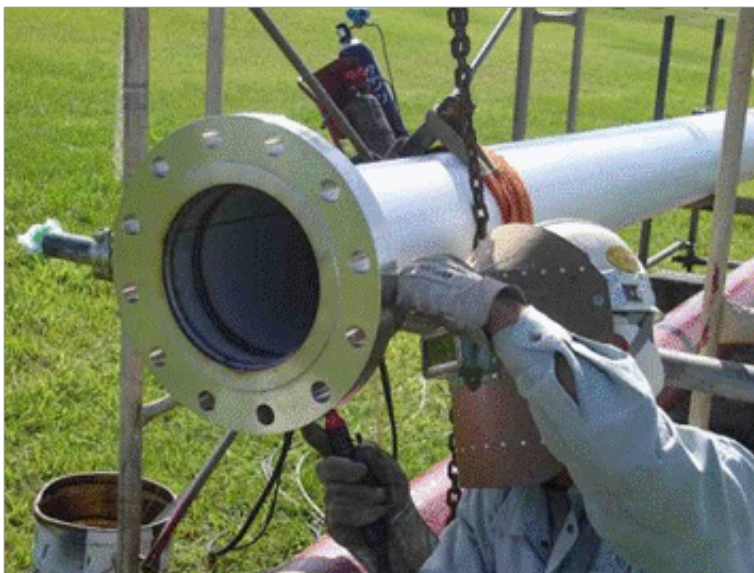
Figure 8. Pipe placement before removal of existing lines.

In general, the project was completed without complications. Several factors helped to account for success in planning and implementation. First, the duration of the assembly period was reduced by welding multiple sections of pipe at a stationary work site. The longer sections were then transported to a final assembly position, reducing the time needed to move and set up welding operations. All sections of pipe were assembled over the route of the existing pipe and pressure tested before connecting to the existing pipe (Figure 8). This reduced the period of time needed to have the fire lines out of service for tie-in. Flanged connections were also pre-assembled to make tie-ins quickly, with only two welds necessary for the final assembly of each section. This method allowed the work to be completed more quickly and at lower labor cost than other similar projects.

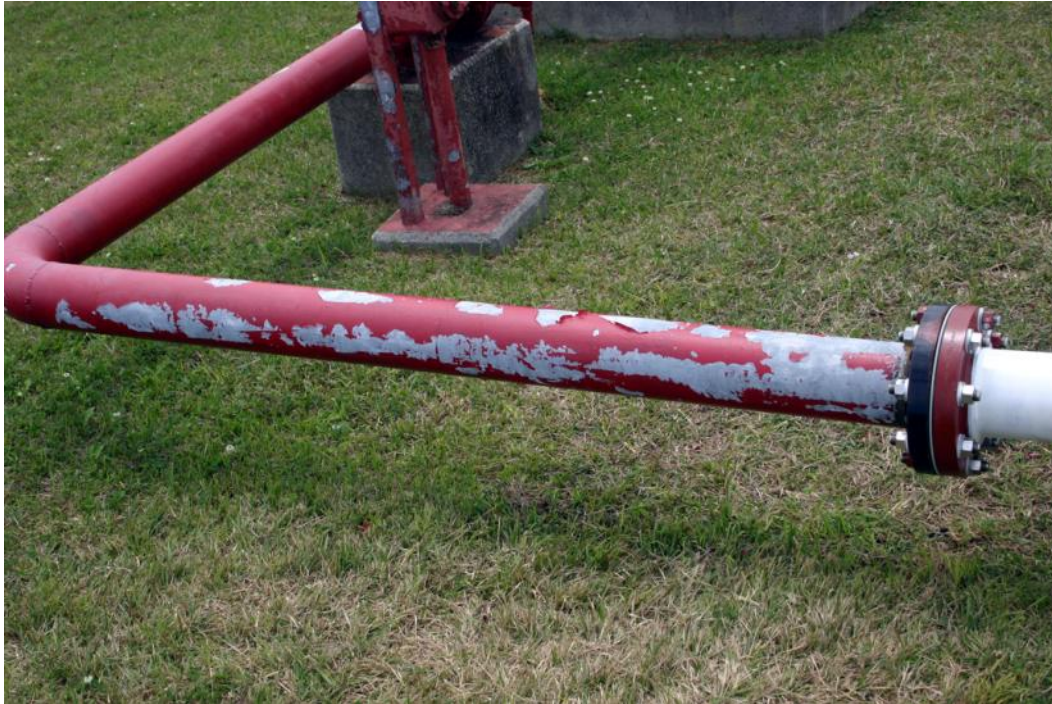
Figure B3. Photograph of the fire suppression supply pipe that was galvanized.

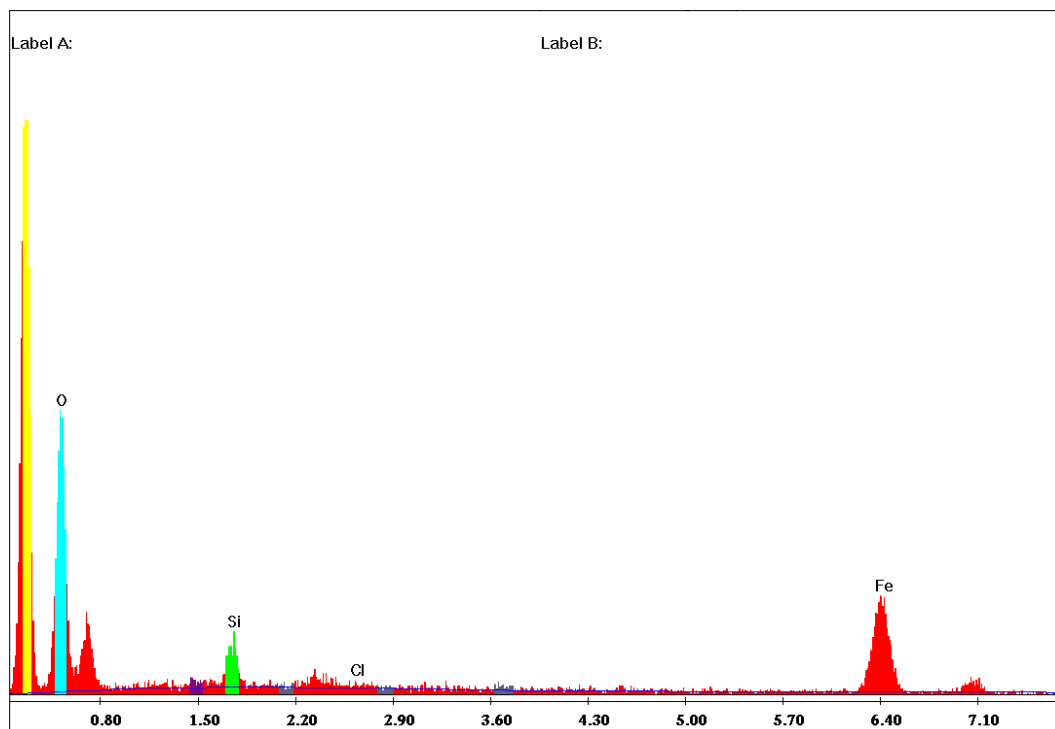
Figure B14. Graph of the x-ray energy versus the number of counts for the area shown in Figure B13.

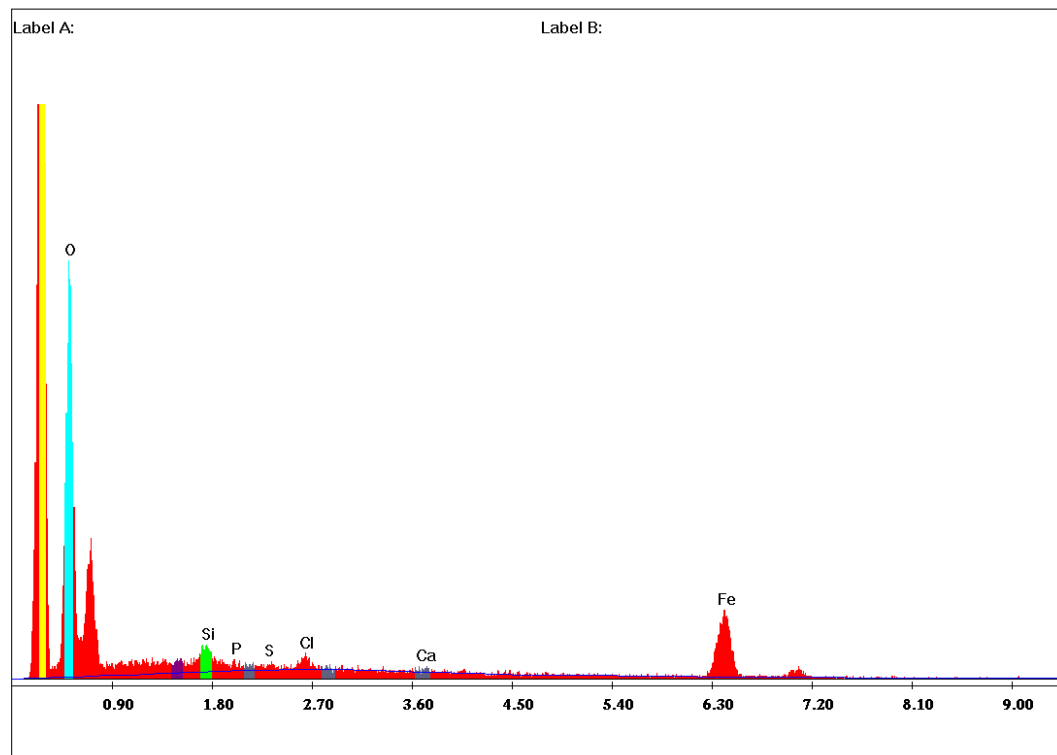
Figure B18. Graph of the x-ray energy versus counts for the area shown in Figure B17.
